Geotechnical Investigation Report

Proposed Secondary Dwelling

37 Mary Street, Goulburn NSW

Report No. R24064. Rev0

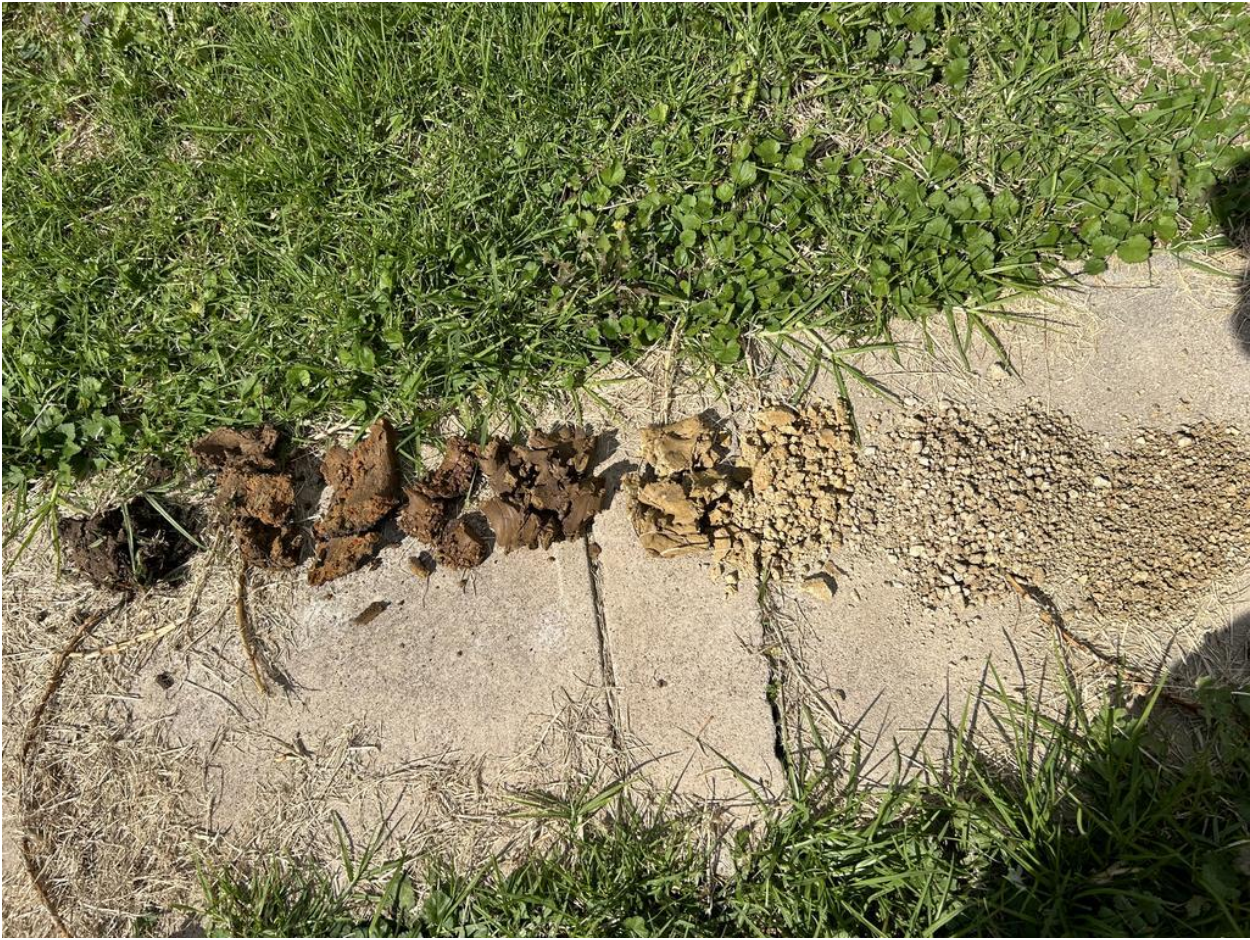
Subsurface Material - BH1

Method	Groundwater	Sample	DCP	SPT	RL	Depth (m)	Classification Symbol	Material Description	Moisture Content	Relative Density/Consistency	Pocket Penetrometer (kPa)	Origin
Solid Flight Auger			1			0.0	SM	Silty Sandy CLAY dark brown, moist, soft	M	So		Topsoil
			2			0.1	CI	Silty CLAY brown/red brown, moist, soft to firm	M	So		Natural
			2			0.2						
			3			0.3	CI	Silty CLAY pale brown, dry to moist, stiff	D/M	St		Natural
			6			0.4						
			7			0.5						
			7			0.6	CI	Silty CLAY pale brown/pale grey mottled, dry, stiff to very stiff, with ironstone/ fine gravels	D	St		Alluvial
			8			0.7						
			8			0.8						
			10			0.9						
			10			1.0						
			12			1.1	CI	Gravelly Sandy CLAY pale grey/pale brown, dry, very stiff, with seams of extremely weathered rock	D	V-St		Residual
			12			1.2						
			12			1.3						
			15			1.4	XW/HW	ROCK pale grey/light brown, extremely to highly weathered rock, with seams of decomposed rock				Extremely to Highly Weathered Rock

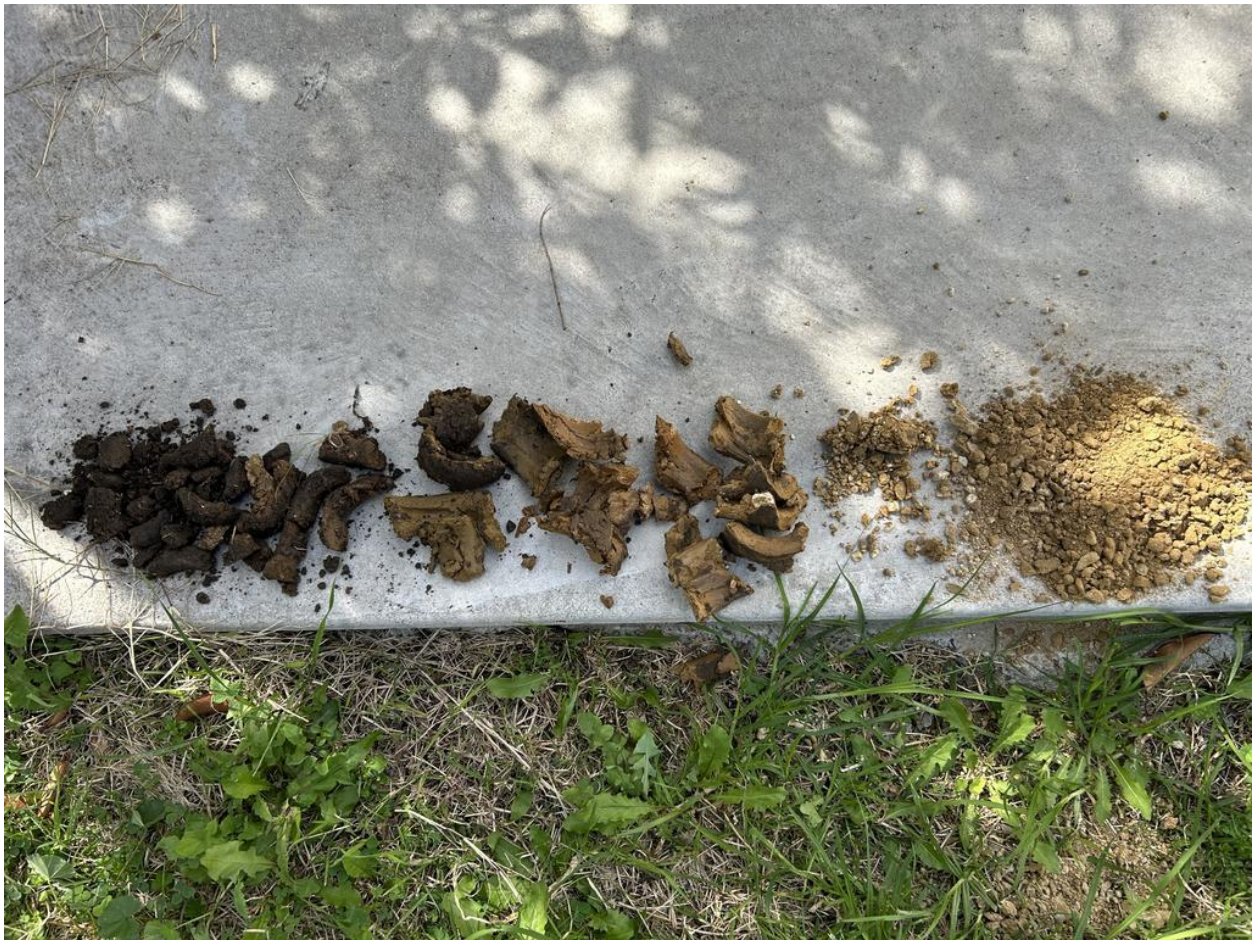
Subsurface Material – BH2

Method	Groundwater	Sample	DCP	SPT	RL	Depth (m)	Classification Symbol	Material Description	Moisture Content	Relative Density/Consistency	Pocket Penetrometer (kPa)	Origin
Solid Flight Auger			1			0.0	SM	Silty Sandy CLAY dark brown, moist, soft	M	So		Topsoil
			2			0.1	CI	Silty CLAY brown/red brown, moist, soft to firm	M	So		Natural
			3			0.2	CI	Silty CLAY pale brown, dry to moist, stiff	D/M	St		Natural
			7			0.5						
			7			0.6						
		8			0.7							
		10			0.9							
		14	Refusal			1.0	CI	Silty CLAY pale brown/pale grey mottled, dry, stiff to very stiff, with ironstone/ fine gravels	D	St		Alluvial
						1.5						
						2.0	XW/HW	ROCK pale grey/light brown, extremely to highly weathered rock, with seams of decomposed rock				Extremely to Highly Weathered Rock
						2.5						
						3.0		Auger Refusal				
						3.5						
						4.0
