WATER CYCLE MANAGEMENT STUDY

**Marulan Childcare Centre
69-73 George St
Marulan**

30th January 2024

ADAMS & ASSOCIATES – HYDRAULICS

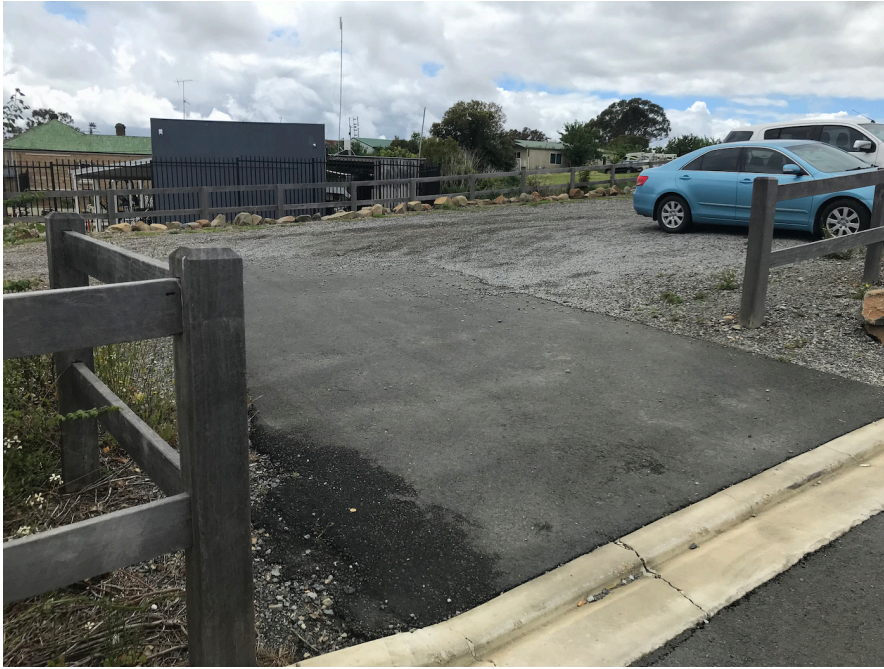
Figure 2 – Existing access from the IGA

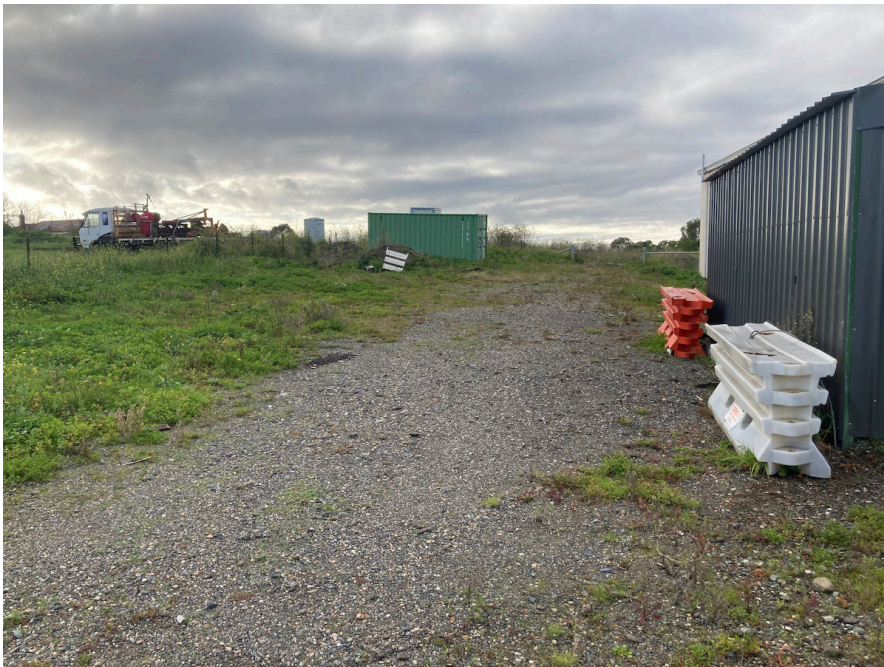
Figure 3 – Existing rear of site

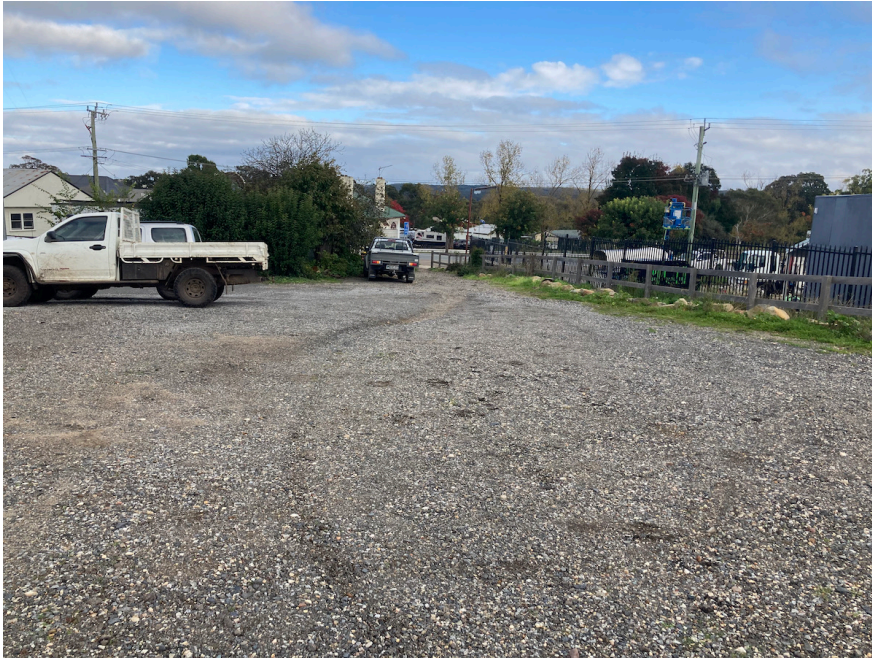
Figure 4 – Site Conditions

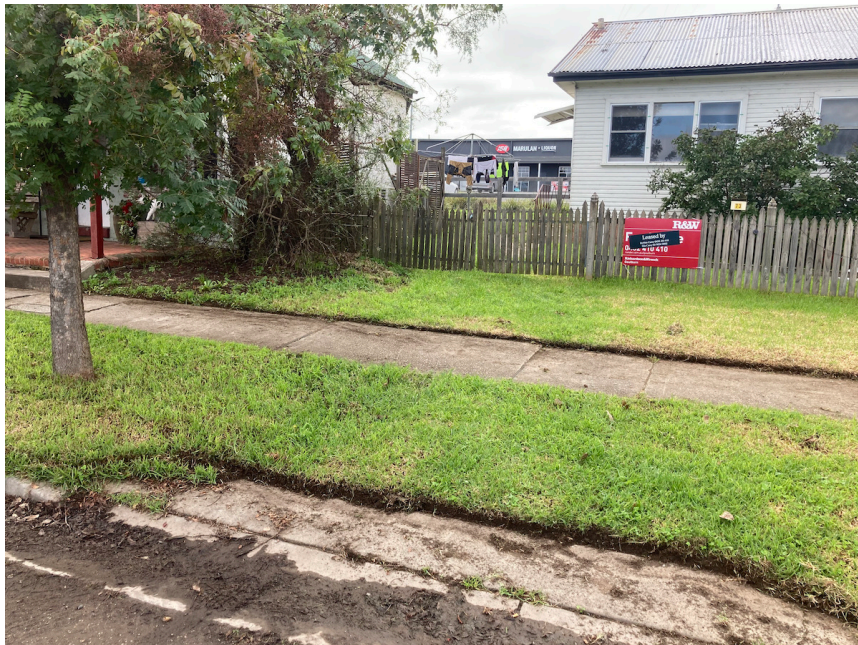
Figure 5 – Discharge point at kerb

The site slopes from the east to the west & runs to George St. Post development stormwater will discharge to the road kerb in George St.
