# Preliminary Site Investigation

36 Howard Boulevard, Goulburn NSW

**Report Title:** Preliminary Site Investigation; 36 Howard Boulevard, Goulburn NSW  
**Report No:** E26297.E01\_Rev0

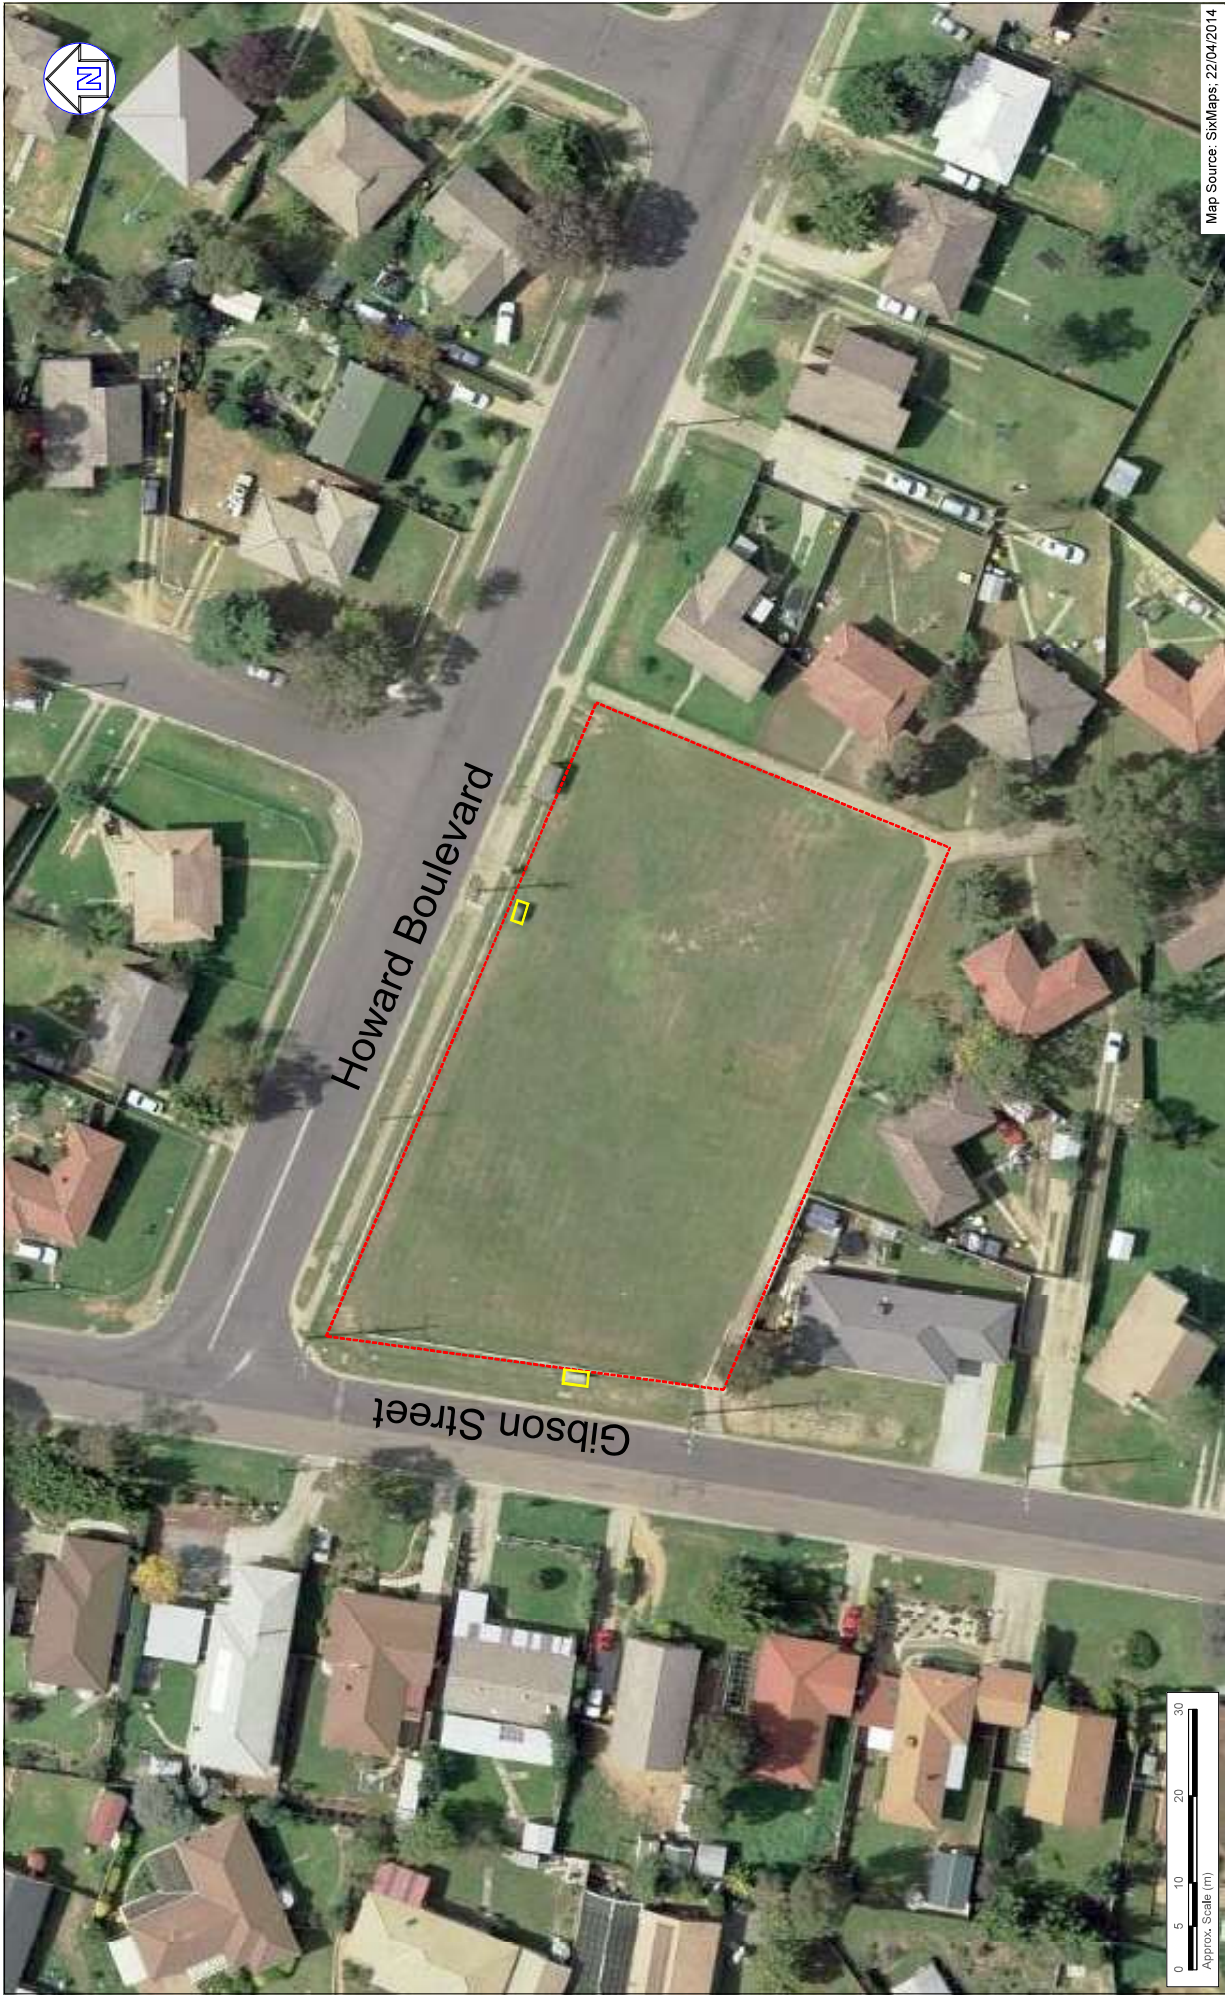
- Use of minor fill/mulch for landscaping or minor levelling;
- Use of fertilisers, herbicides or pesticides for park management;
- Leakage for any mowers used to maintain the grass;
- Leaking of adjacent electrical power boxes, along Howard Boulevard and Gibson Street (see **Figure 2, Appendix A**);

- Site boundary
- Electrical power box locality

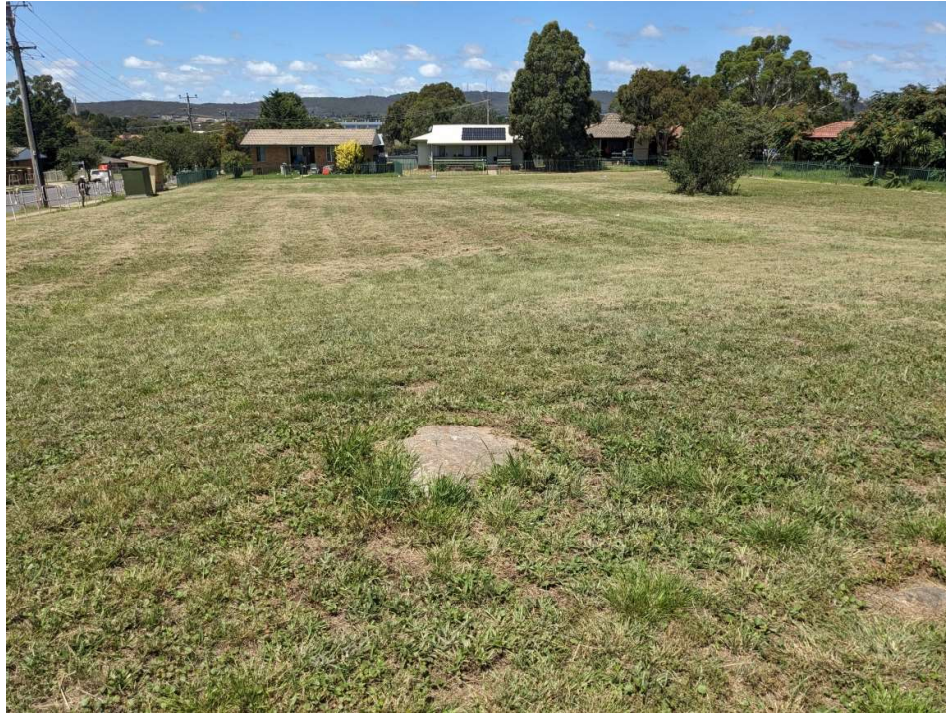
**Photograph 1:** View of the site facing east from Gibson Street. Rock outcrops can be seen exposed in the foreground, and the lone small tree in the background.

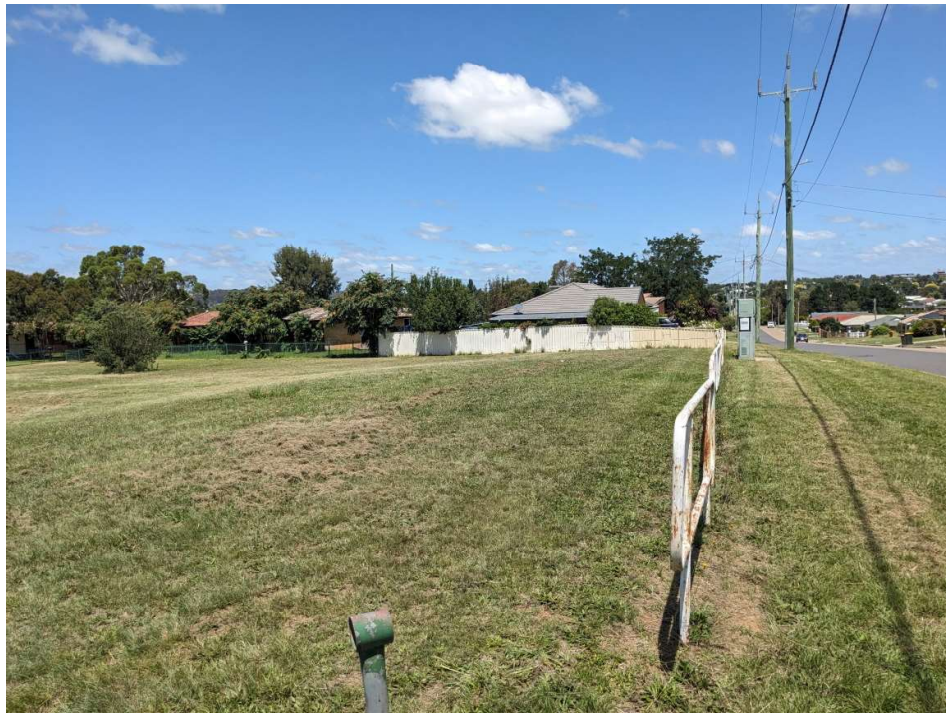
**Photograph 2:** View of the western boundary of the site, from the intersection of Howard Boulevard and Gibson Street, facing south along Gibson Street. Low residential properties can be seen in the background.

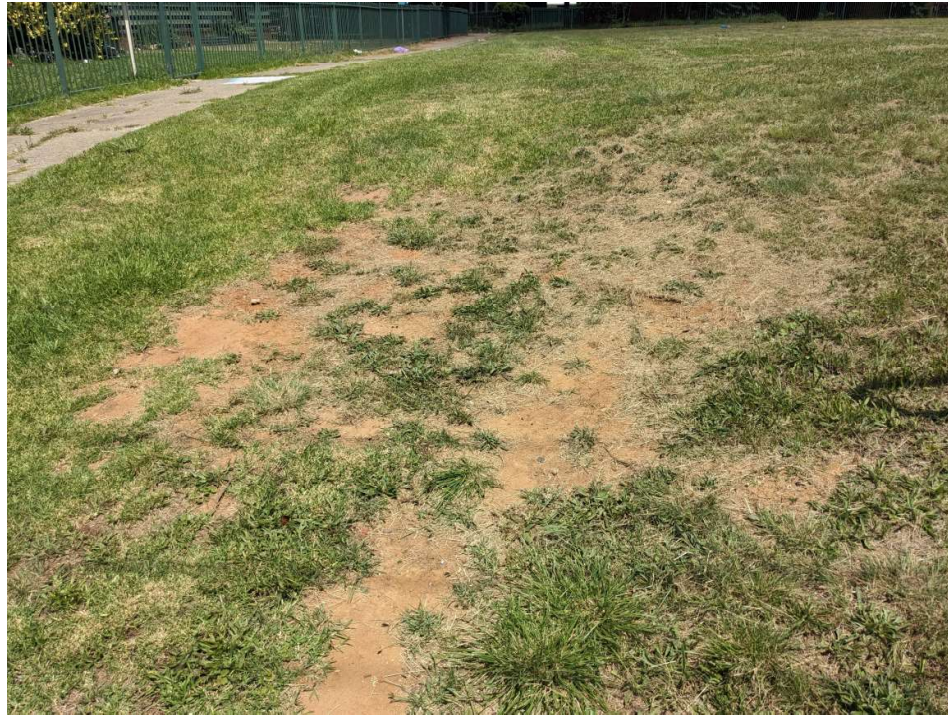
**Photograph 3:** Example of exposed natural soils identified throughout the site.

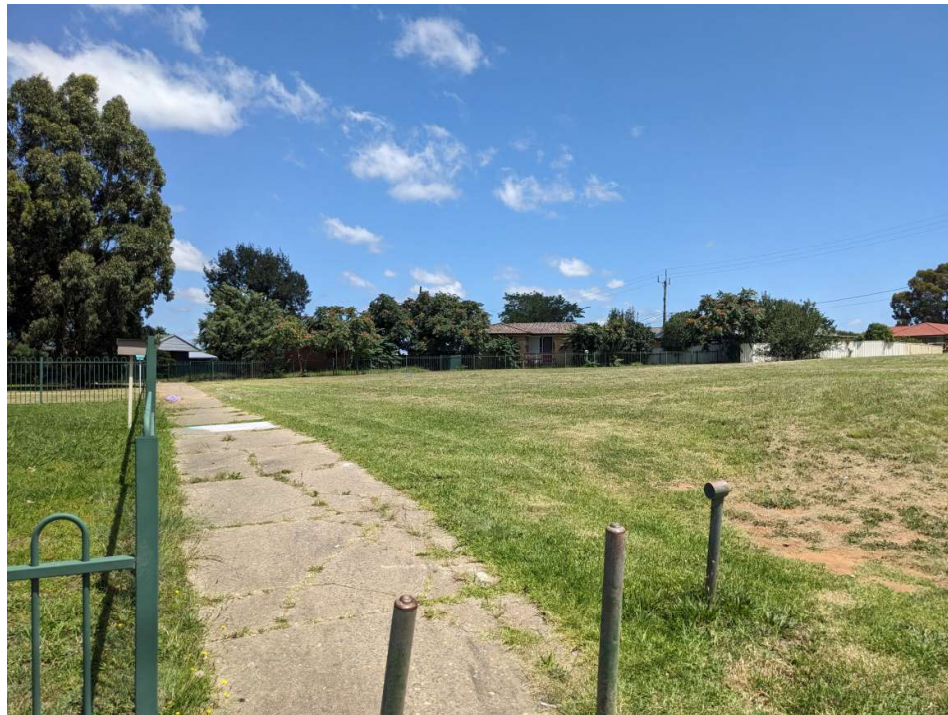
**Photograph 4:** View of the site from the eastern corner, facing towards the south west. The public pathway that runs along the eastern boundary can be seen in the foreground, with low density residential properties further to the left (east).

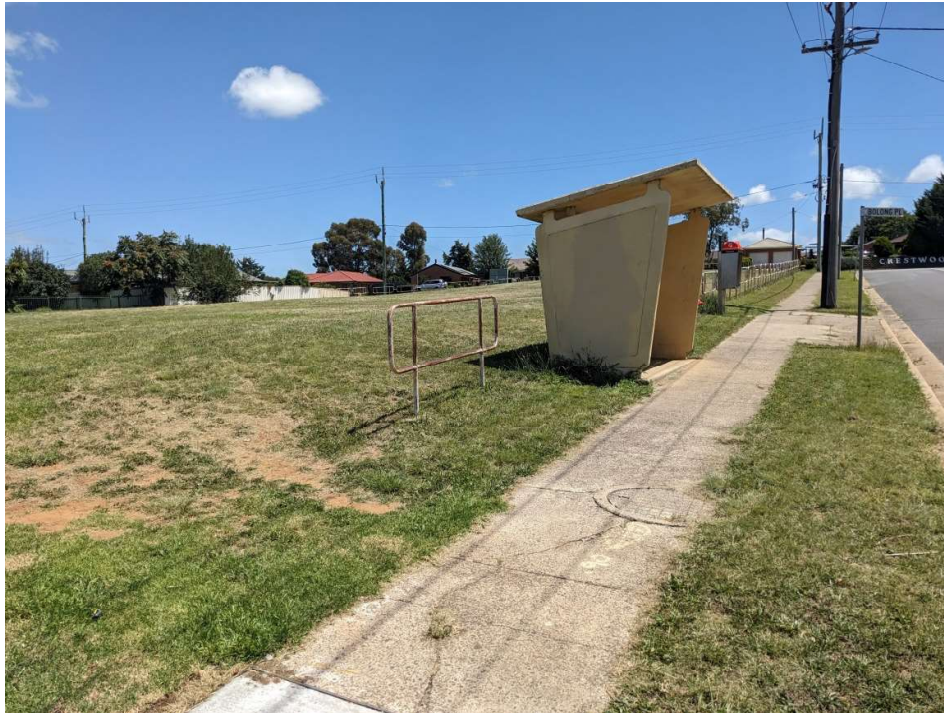
**Photograph 5:** View of the site facing west along Howard Boulevard.

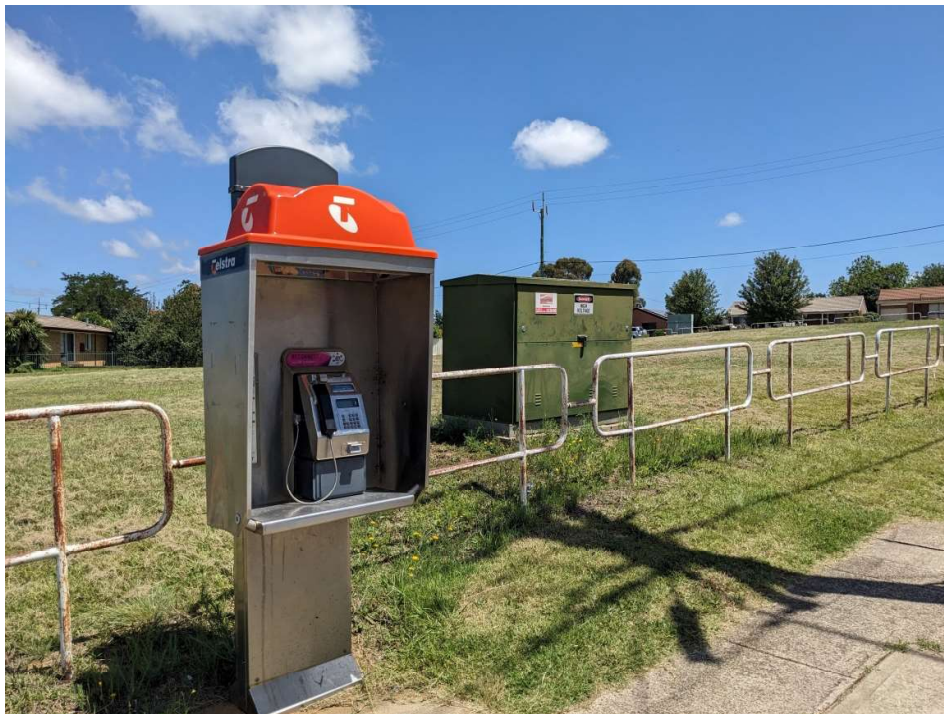
- A Telstra phone box and electrical sub-station kiosk were located along Howard Boulevard, along the site's northern boundary. An additional substation kiosk was noted outside of the site's western boundary. There was no visual evidence of leakage from either facility (**Photograph 6**).

**Photograph 6:** Telstra payphone and electrical box located along Howard Boulevard.
