AS2870-2011 SITE CLASSIFICATION

Hotondo - Goulburn
113 Marys Mount Road
GOULBURN NSW 2580

Lot 14 No 19 Snowgums Drive
Goulburn NSW

AS2870 Site Classification
Class P
Estimated AS4055-2021 Wind Classification
N3

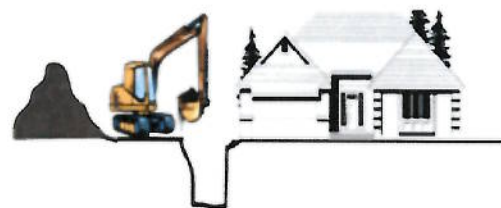
Fig. 11 De-stabilizing house foundations

- Ensuring that excavations are well supported or are dug to avoid collapses. (Fig. 11)
- Constructing well-compacted and retained 'soil aprons' around the building to stop erosion.

- Special considerations if any excavations are to be dug near adjoining structures.(Fig. 11)
- Sloping the soil and paths away from the building by the minimum amount required by the building regulations to prevent water flowing towards the building foundations. (Fig. 10 & 18)

- Running machinery over shallow drain pipes may break them causing leaks and subsequent foundation movements.
- Any excavations close to building footings can cause them to sink by disturbing the foundation material or by drying the foundation clay. (Fig 11)
